Glove Box Sealing Options

Steve Hardy

February 14, 2006

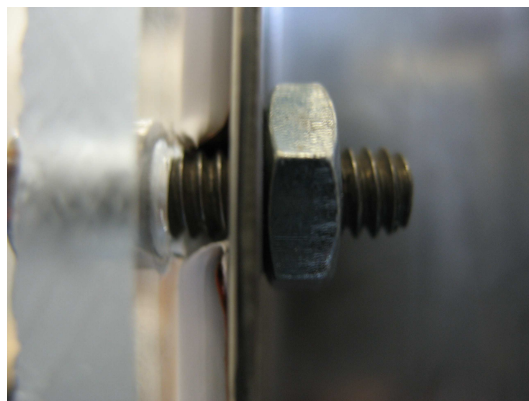
Figure 4: Sample 3 Exterior View, Note that the seal has ripped around bolts

We ultimately strive to be able to produce a consistent set of seals, and spares, that will work without failure during installation and subsequent removal of panels, acrylic, etc. The EPDM material is far easier to work with than the expanded teflon, mostly due to the "memory" that the EPDM possesses. Boring the bolt holes in the EPDM is a very simple process, whereas the teflon is very easy to tear if one does not make a clean cut and take care when withdrawing the bore. However, just as one would think, applying the tape to a rectangle is much easier than it is to a flat bottom and a rounded surface, especially with the stainless steel tape (the Cu tape essentially eliminates this problem). The EPDM is also much more forgiving when one needs to correct a misalignment of the tape, the strong adhesive on the tape tends to tear the teflon into strips. I must also strongly recommend that we place the bolt holes in the center of the seal, as Figure 4 shows, the off center placement of the bolt holes causes the seal to rip away from itself under bolt insertion and compression.

* Seal tore at bolt holes
